Post Storm Response and Recovery at the Texas Medical Center

Including a Comparison with Ike at UTMB

Charles M. Penland, P.E.
Senior Principal
Walter P. Moore and Associates, Inc.

Post Allison Response and Recovery at the Texas Medical Center

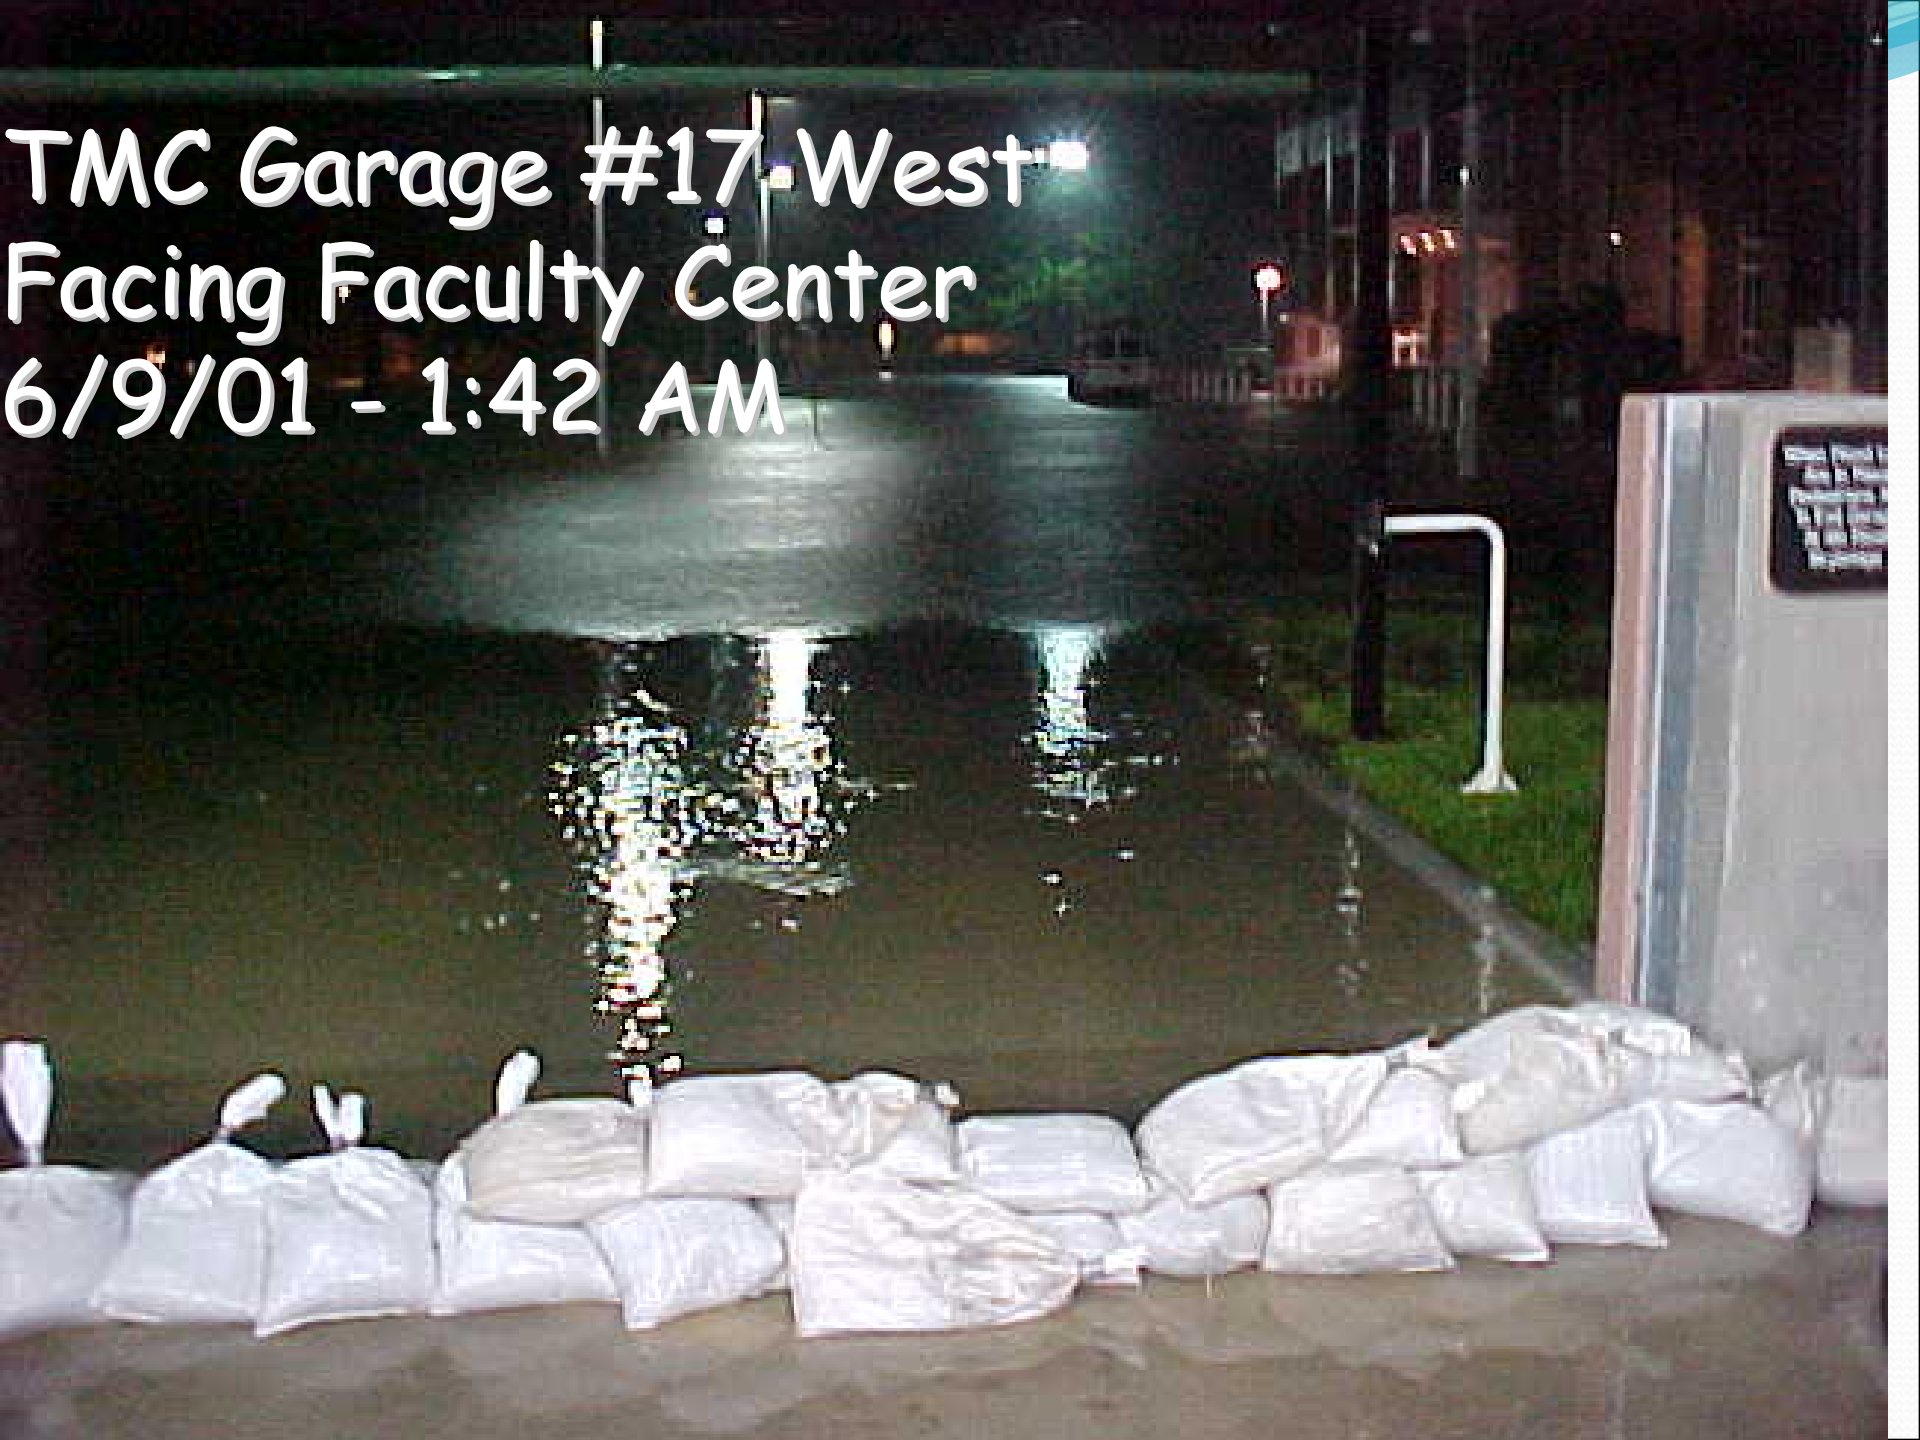
TMC Garage #17 - West
Facing Faculty Center
6/9/01 - 1:42 AM

Debris Line High
Water Mark

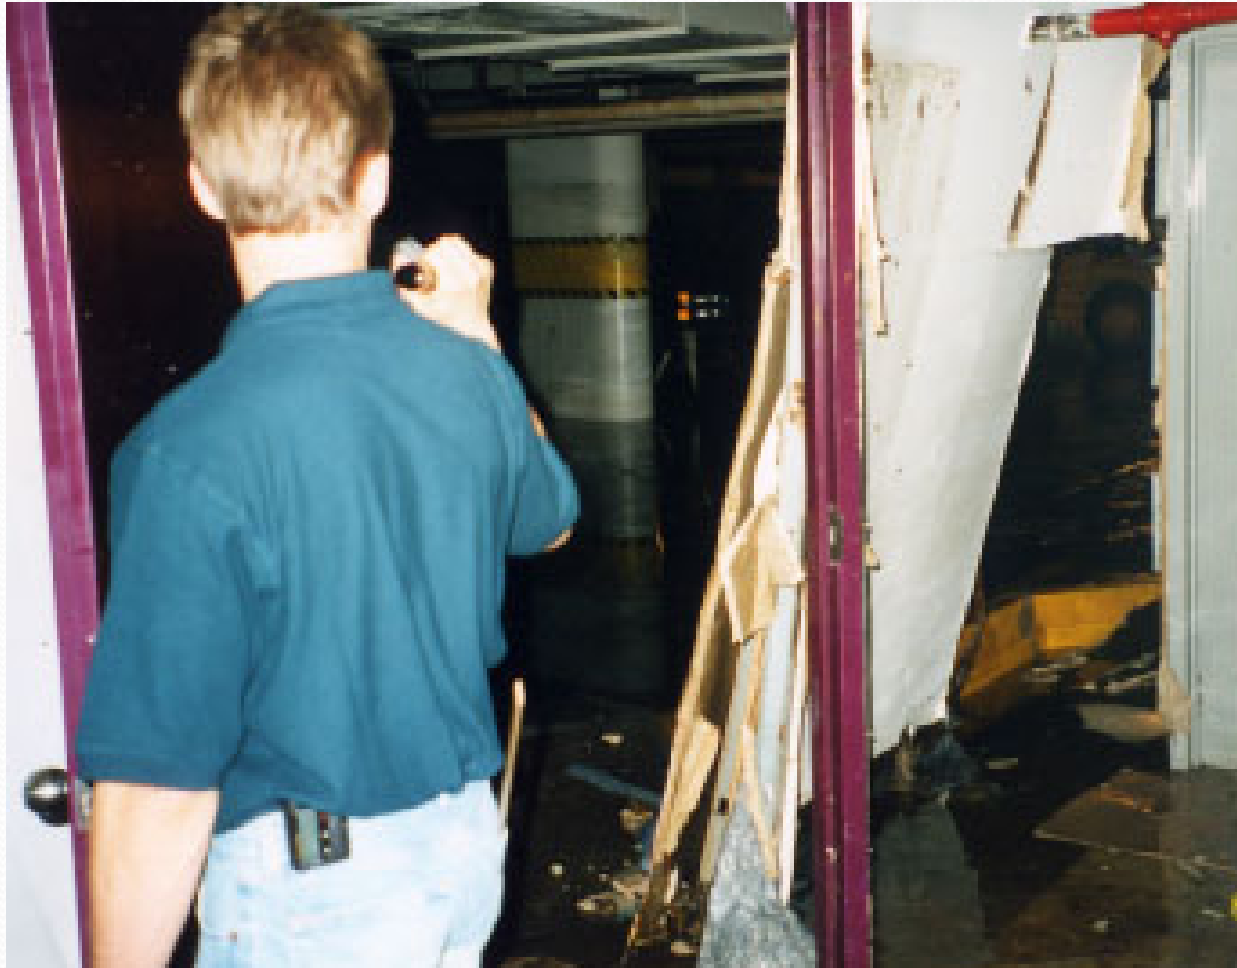
Damages in TMC Garage #1

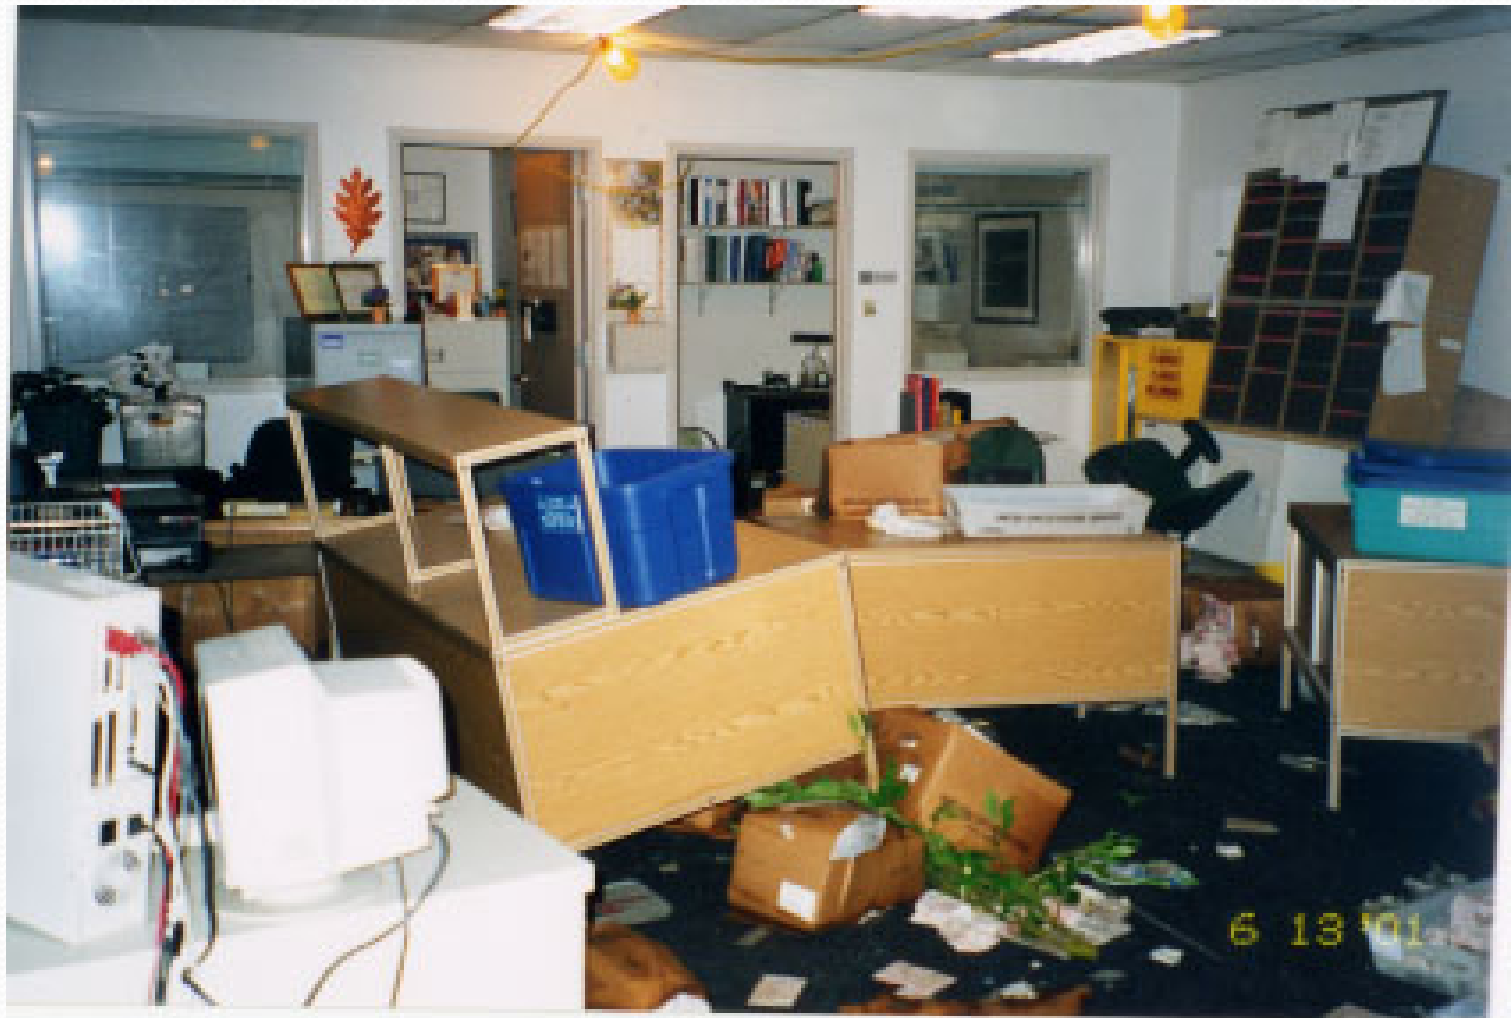
Damages to Basement Offices

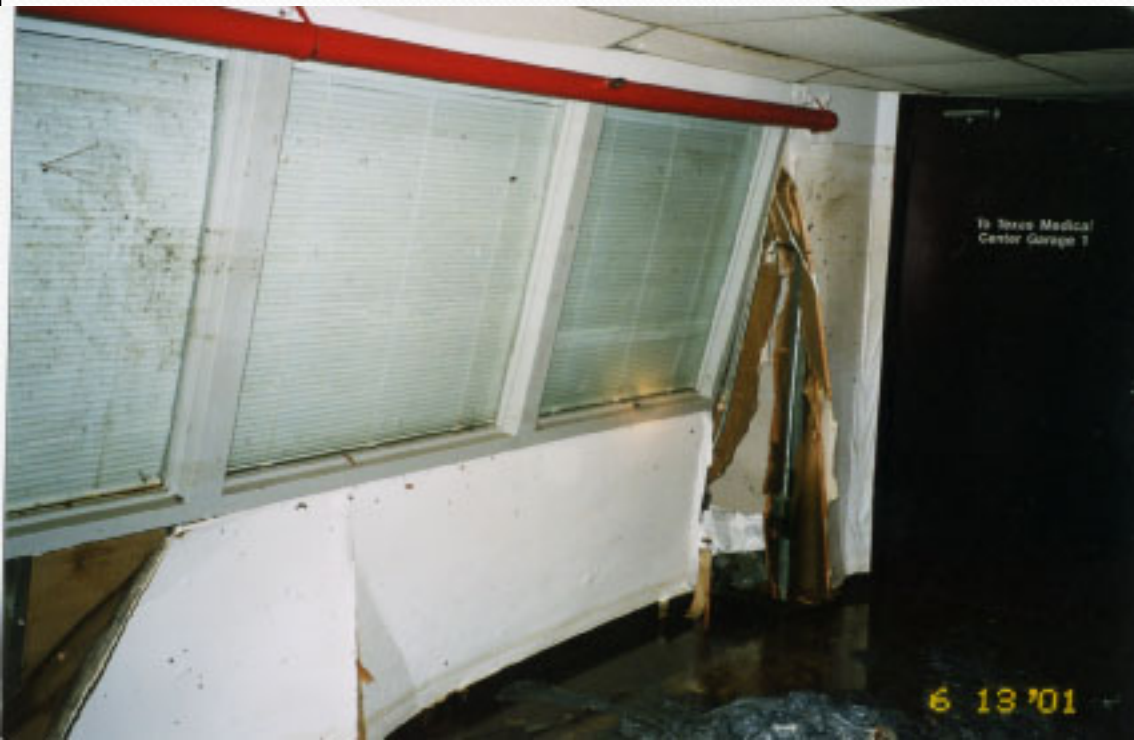
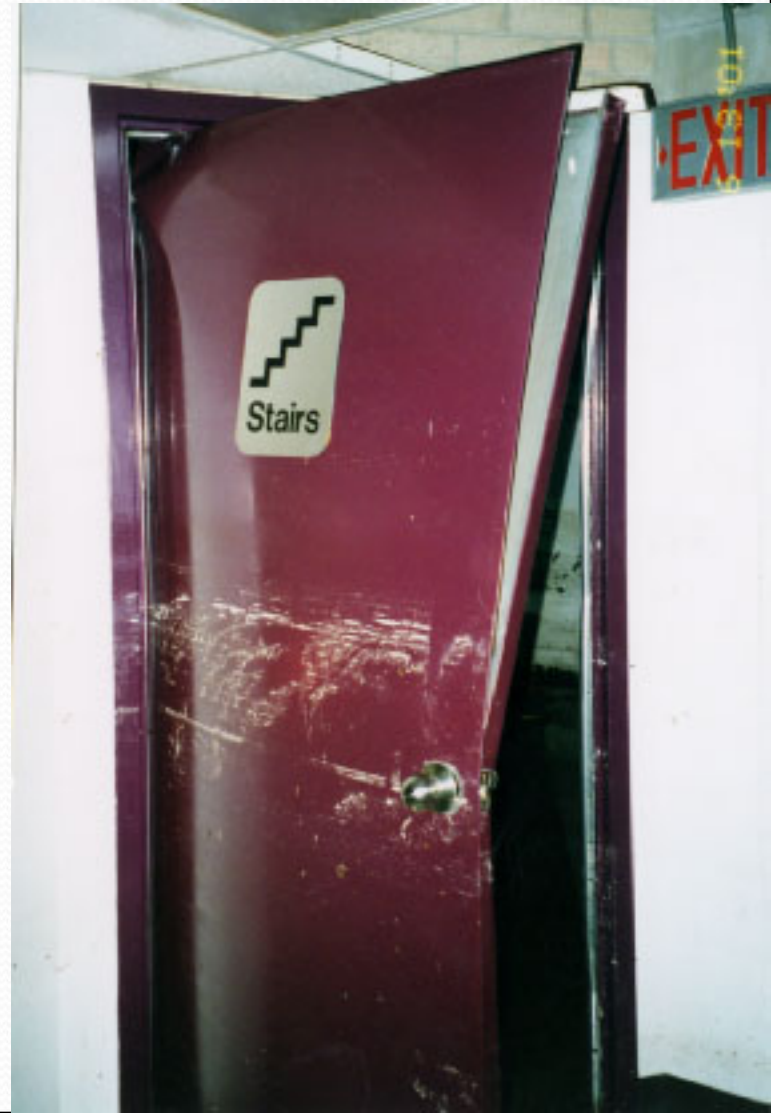
Water Pressure Blowouts
